# Clay Deposits and Early Brick-making in Addison County, VT

Erich Pfeffer

## Overview

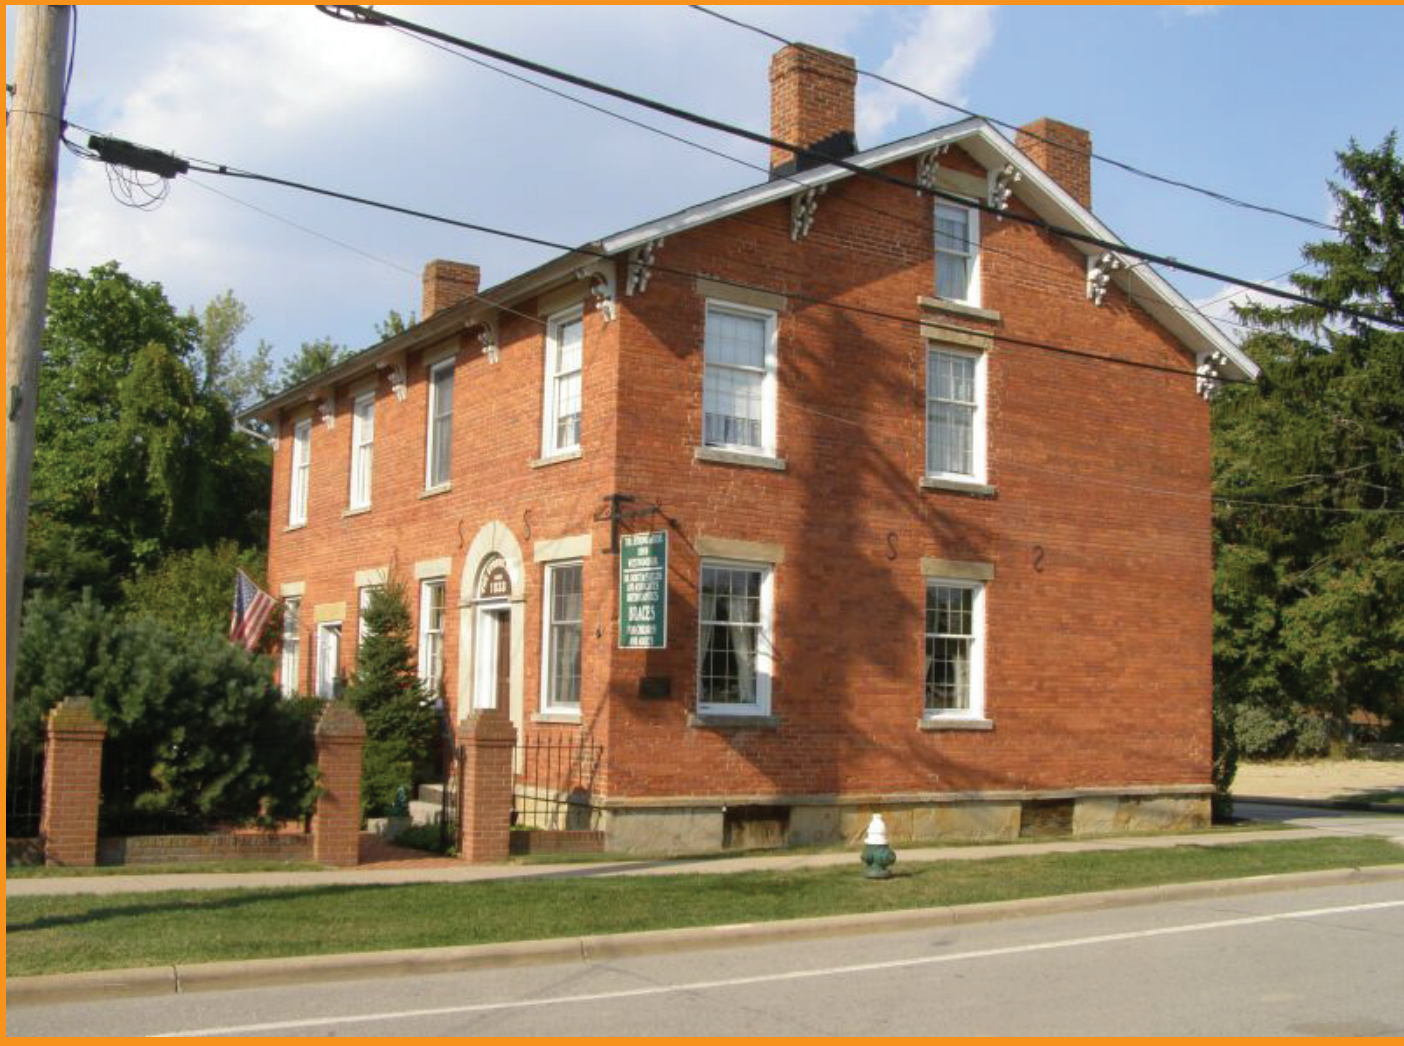
**Figure 1.** In the towns of Addison, Middlebury, New Haven, and Weybridge, brick architecture is very prevalent. This is a picture of the John Strong House in Addison. It was one of the first brick buildings constructed in Addison County during the 1790's. Bricks for the house were made on site.

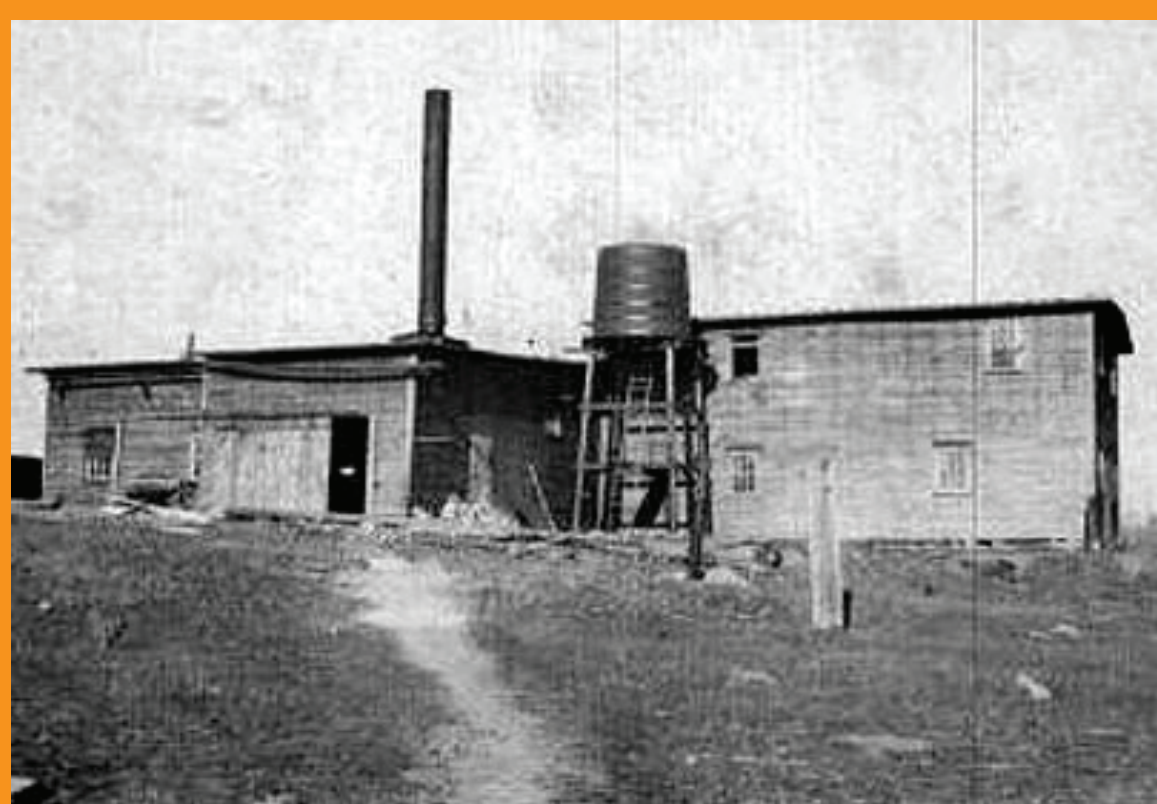
**Figure 5.** An early clay mine (left), and an early “pug mill” (right).

- 1.) The first step of the brick-making process was to mine a pure kaolinite, blue clay deposit, with a low content of carbonate lime. *Digging* occurred in the fall to allow clay to freeze and thaw during the winter. This clay tempering process, which took place in a horse-driven “pug mill”, was a crucial and labor-intensive part of the brick making process. *Tempering* through weathering, wetting, kneading, and sand addition made the clay more plastic and workable.
- 2.) Lumps of tempered clay were pressed into a wooden or metal *mold* consisting of many rectangular slots. Molds were lubricated with water and sand early on, but later brick-makers used animal oil to achieve a sharp-edged product. Once shaped and removed from their molds, the bricks were labeled *green*.

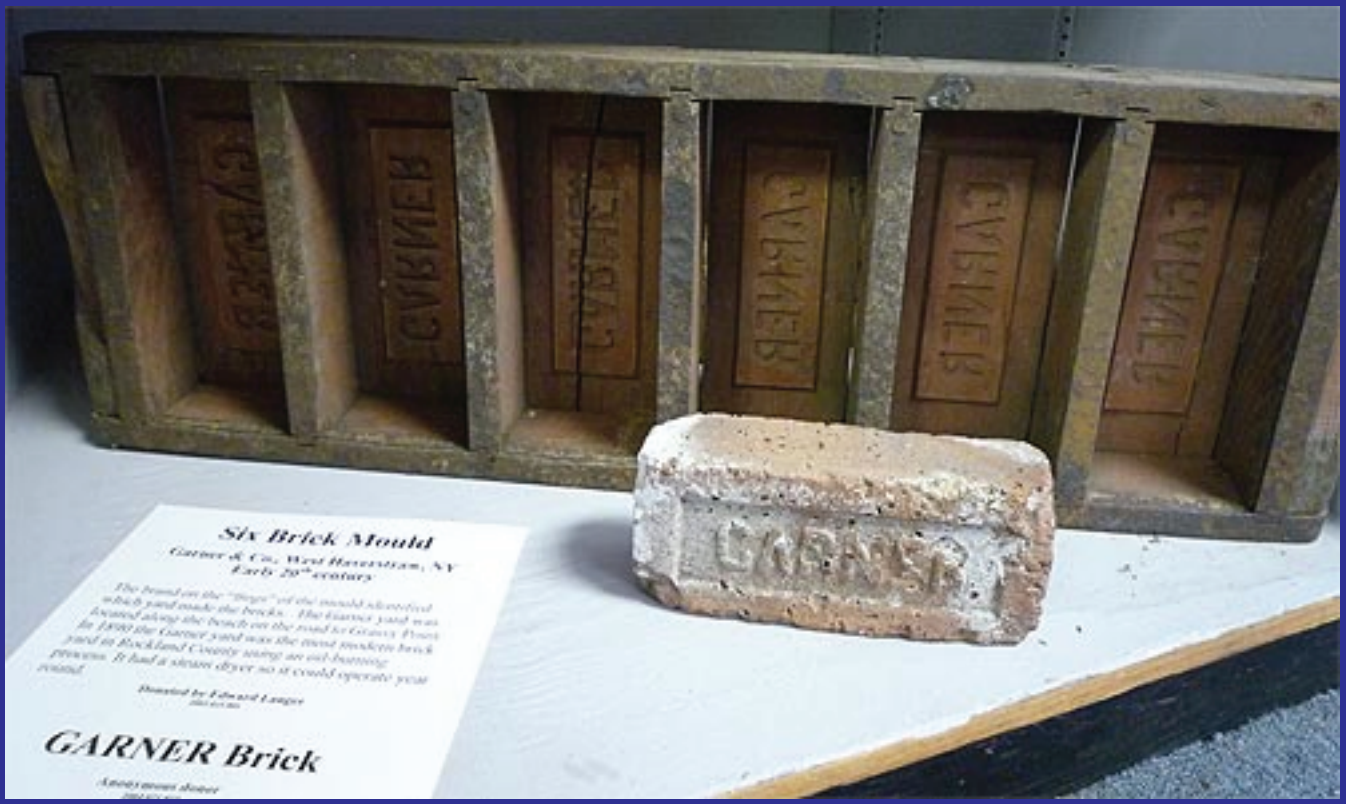
**Figure 6.** An example of an early wooden 6 brick mold. Laws were created early on to regulate the size of bricks to 9 inches in length, 4 ¼ inches in depth, and 2 ½ inches in height. Such regulation made it easier for bricklayers to complete projects accurately.

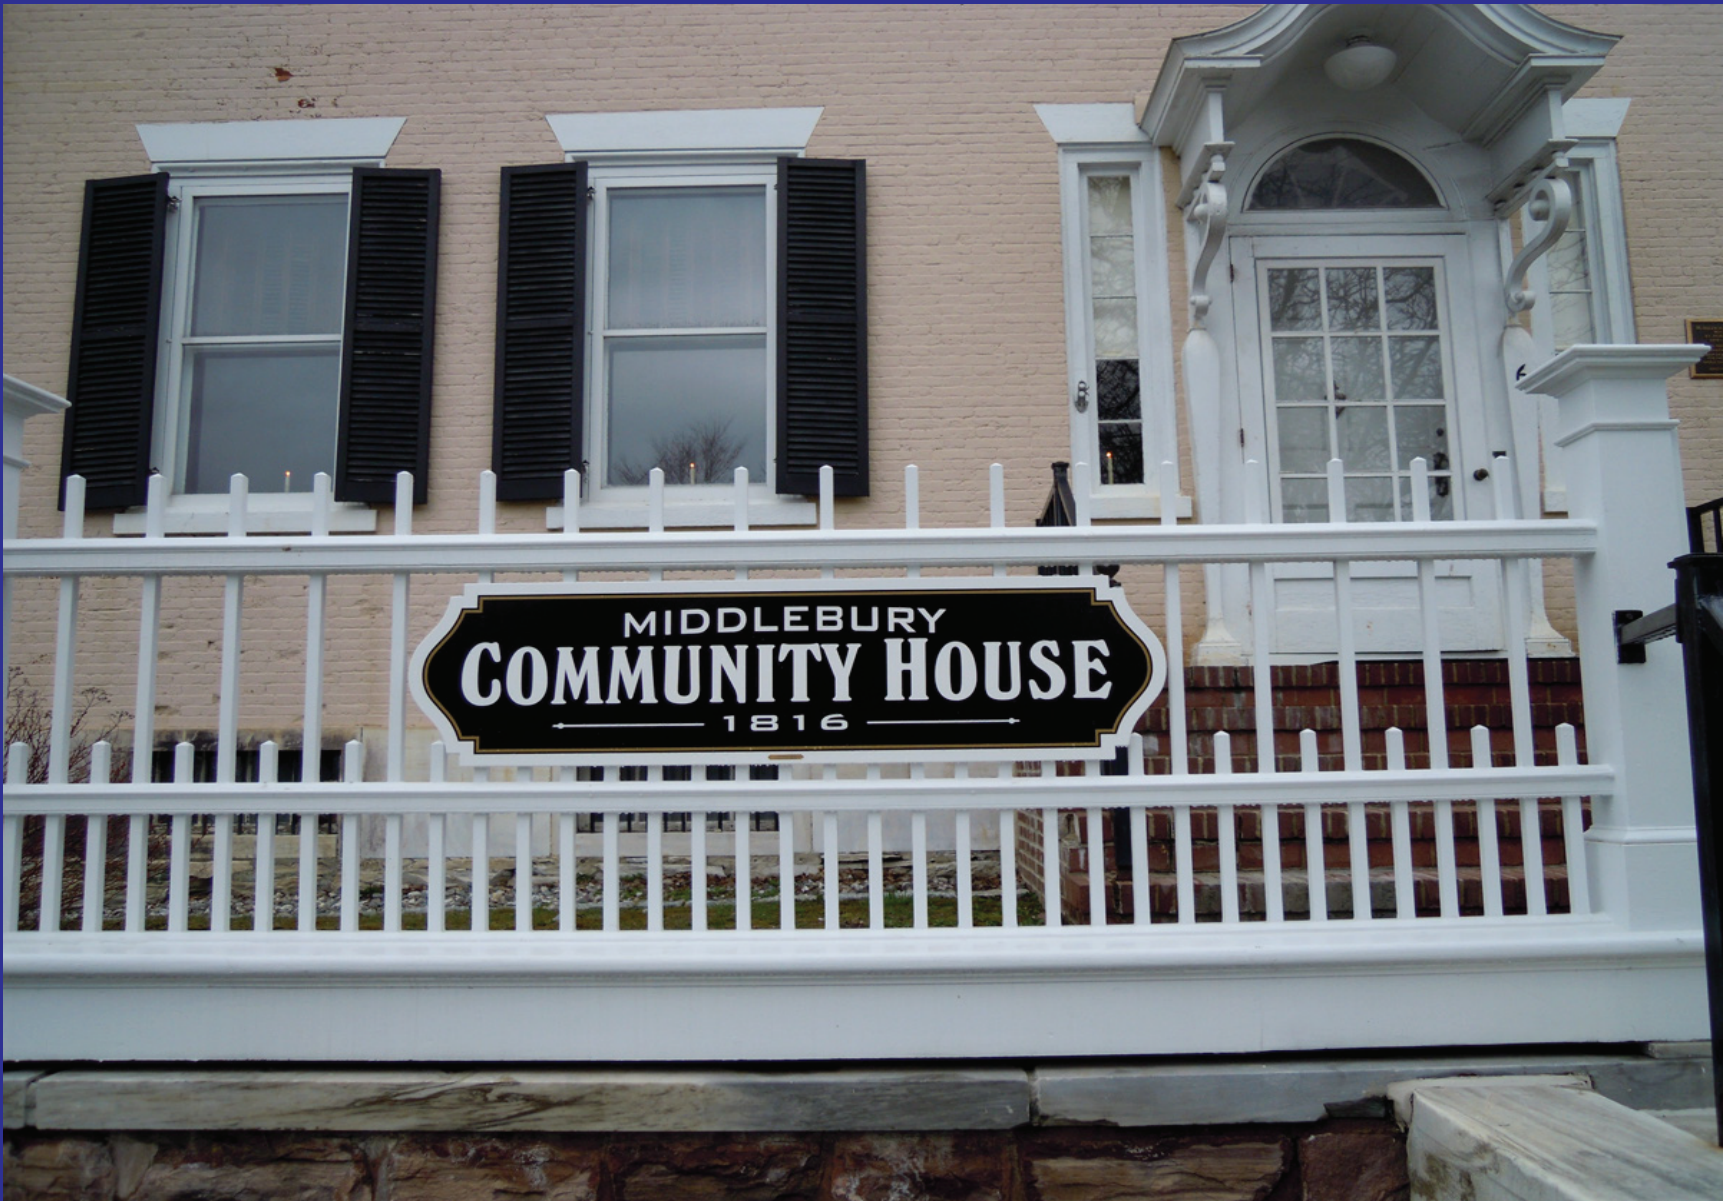
**Figure 8.** The Community House in Middlebury is a perfect example of brick failure. The house has been painted since it was first built to prevent the brick exterior from crumbling off the frame.

Many early brick buildings crumbled at a young age due to the rapid weathering that took place on bricks with a high percentage of carbonate lime. Early *brick failure* could also have been attributed to the use of impure clay. Clay that did not contain mainly kaolinite, but instead smectite, vermiculite, or a lot of sand and gravel, would have undergone shrinking and swelling in dry and wet conditions.
